Case Study

Diagnosing and Resolving a Mysterious Slow Wi-Fi Issue in a TP-Link PoE Network

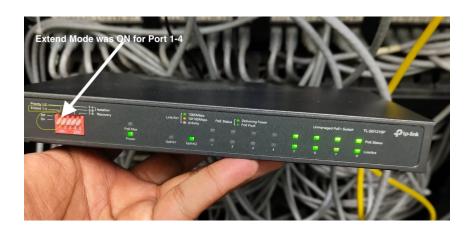
Upon further inspection of the TP-Link PoE switch specs, we identified a feature called Extend Mode. When enabled, this limits port speed to 10 Mbps, typically used for long-distance PoE connections (e.g., CCTV beyond 100 meters).

We requested a photo of the client's PoE switch and confirmed that Extend Mode was enabled on Ports 1-4.

- Disabled Extend Mode on Ports 1-4.
- Reconnected the AP in the CEO's cabin.
